RESIDENTIAL INSPECTION COPY

123 Inspection Lane
Hiram, Ohio 44234

John Doe
OCTOBER 26, 2022

1: Inspection Details	4
2: Exterior	5
3: Roof	12
4: Interiors	17
5: Basement, Foundation, Crawlspace & Structure	26
6: Heating	29
7: Cooling	33
8: Plumbing	35
9: Electrical	45
10: Fireplace	51
11: Attic, Insulation & Ventilation	52
12: Built-in Appliances	54
Standard of Practice	59

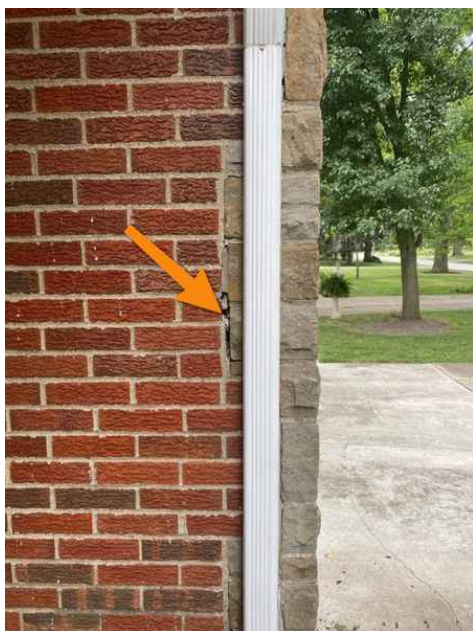
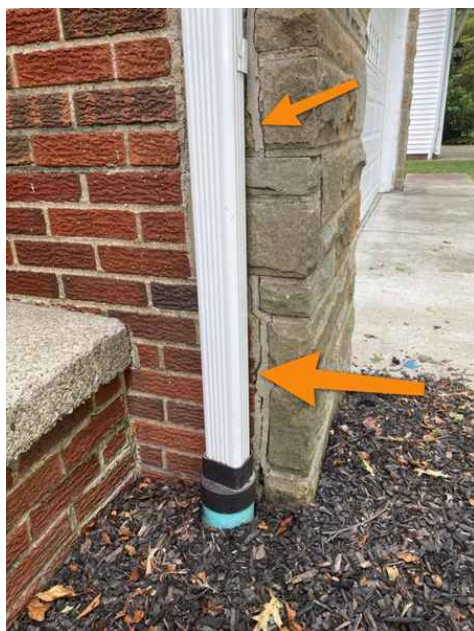
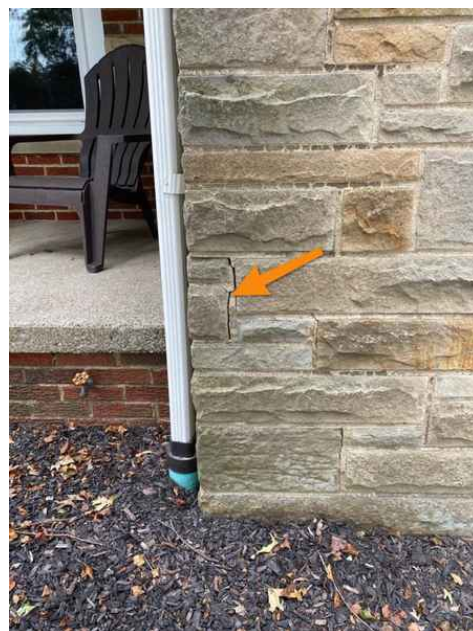
DAMAGED MORTAR

Some of the mortar between the stone has fallen out and is allowing water to enter. When the water freezes in the winter it will expand and further damage the stone and mortar.

Stone Mortar Cracking

Recommend tuck point repairs to the damaged areas by a qualified professional to prevent further damage.

Contact a qualified professional.

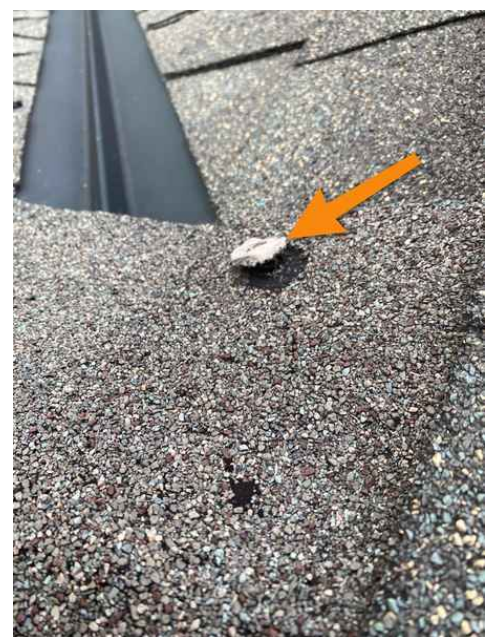
POTENTIAL WATER INTRUSION

Exposed nail was observed on the front side of the roof. This should be resealed to prevent potential water intrusion.

Compromised Sealant front

Contact a qualified professional.

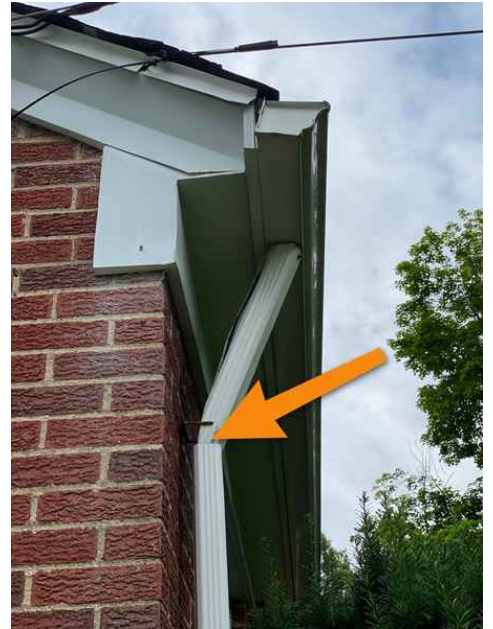
RESTRICTED FLOW

The downspout was observed to be restricted. Recommend a qualified professional repair to prevent potential water intrusion.

Restricted Downspout Right Rear

Contact a qualified professional.

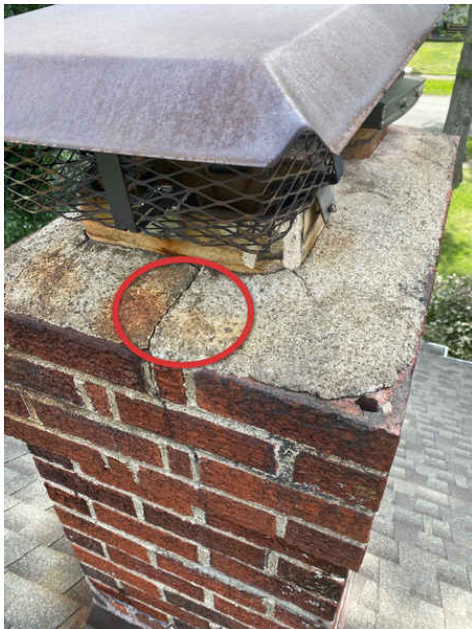
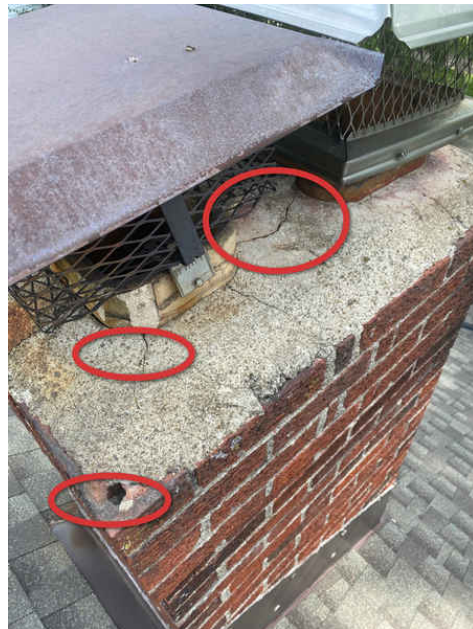
CHIMNEY CROWN CRACKED

The crown of the chimney was observed to be cracked in multiple places. Recommend that a qualified masonry professional repair to prevent potential water intrusion.

Cracked Crown

Contact a qualified professional.

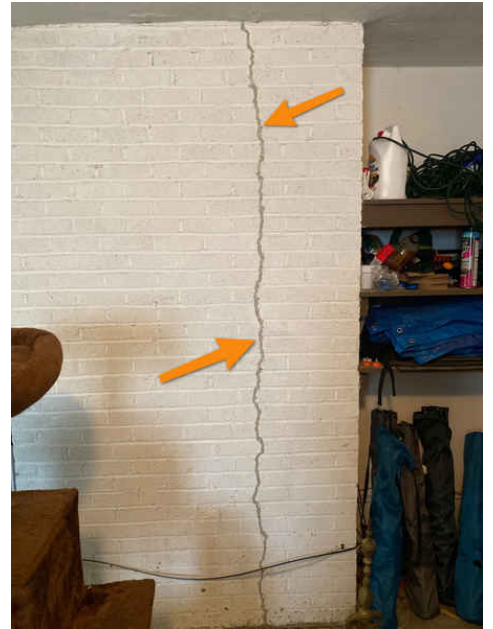
CRACKED MASONRY/CHIMNEY

The section of chimney exposed in the garage exhibited previous crack repairs. Recommend monitoring this area and consulting with a qualified masonry professional for repair if condition worsens.

Repaired Crack

Contact a qualified professional.

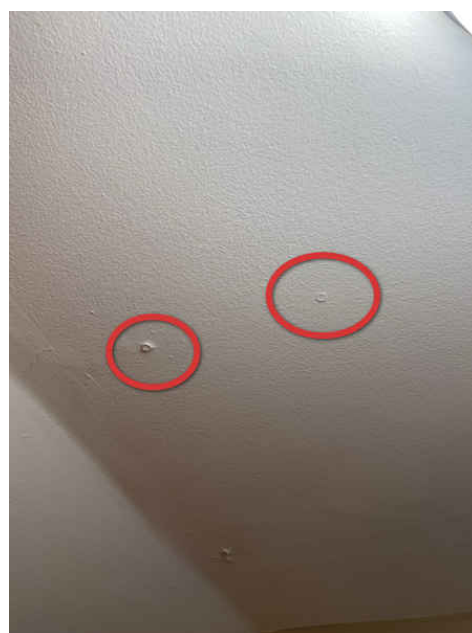
NAIL POPS

Protruding nail heads visible at the time of the inspection appeared to be the result of contact with moisture. After the source of moisture is located and corrected, protruding nails should be removed, drywall re-fastened and the drywall finished to match the existing wall surfaces. All work should be performed by a qualified drywall or painting contractor.

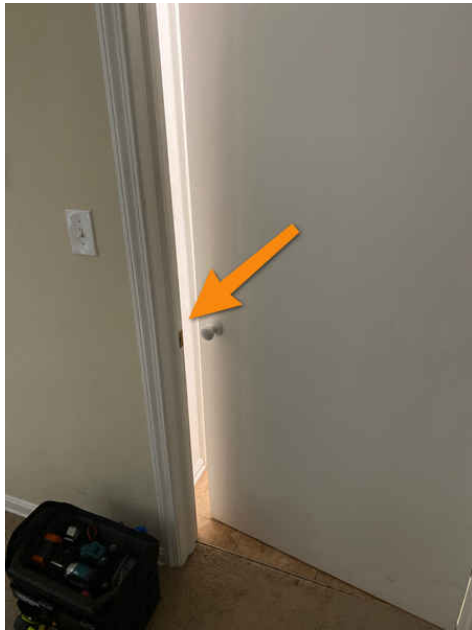
DOOR DOESN'T LATCH

Door doesn't latch properly. Recommend handyman repair latch and/or strike plate.

Entryway Door Doesn't Latch

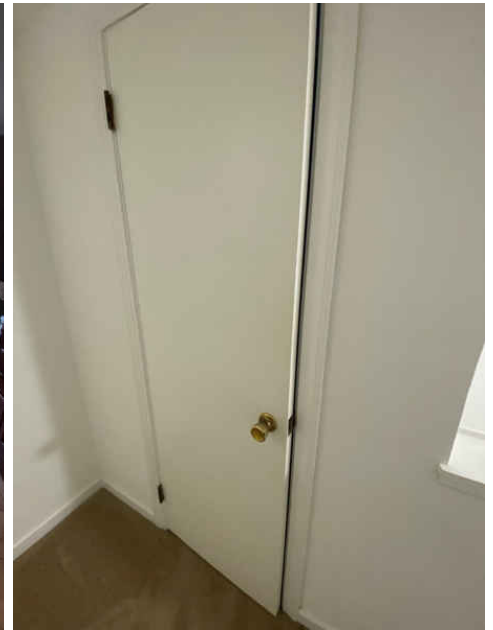
2nd Floor Storage Closet

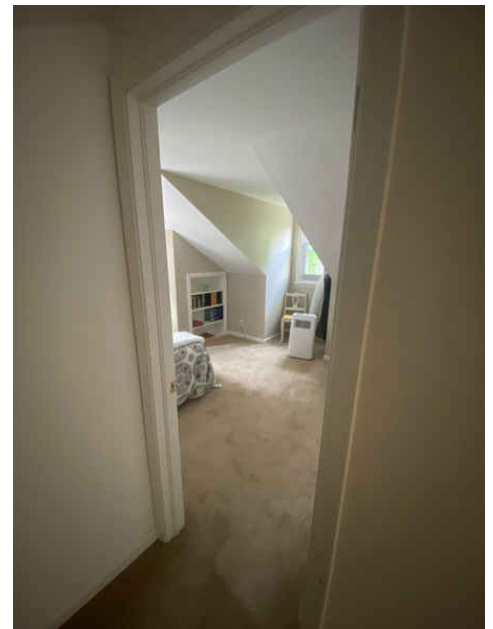
DOOR STICKS

Door sticks and is tough to open. Recommend sanding down offending sides.

2nd Floor Left Bedroom

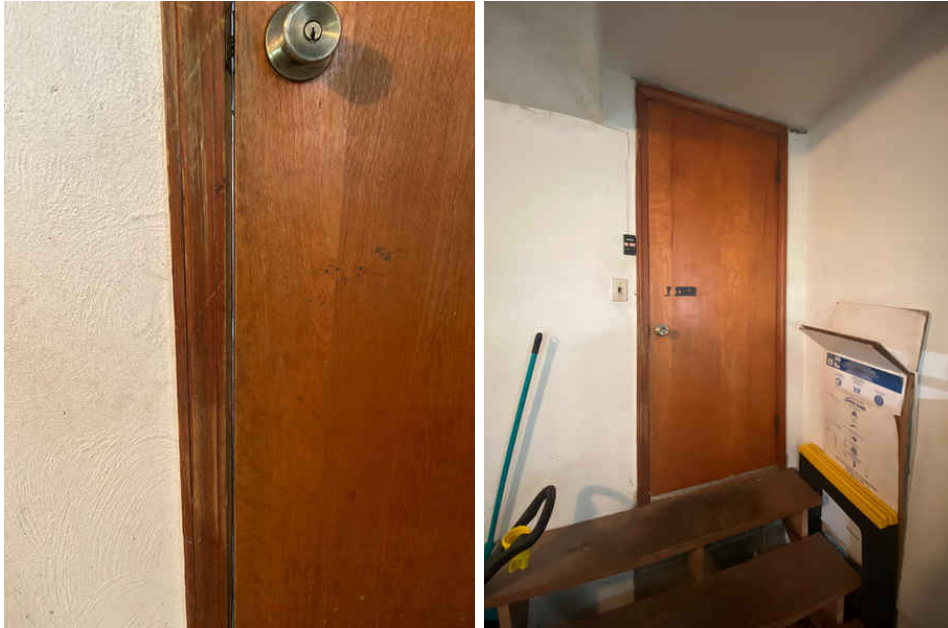
IMPROPER DOOR

The door from the garage to the house was observed to be wood and not rated to stop the spread of fires. We strongly recommend that this door be replaced with a fire rated steel entry door by a qualified professional.

Poor seal around door/light passing through while closed

Wood garage entry door

Contact a qualified professional.

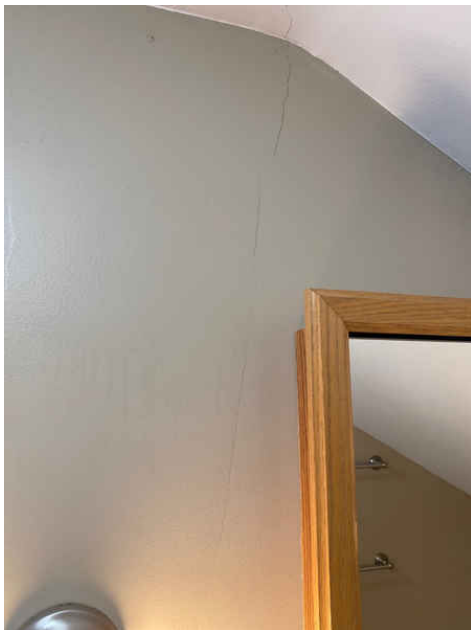
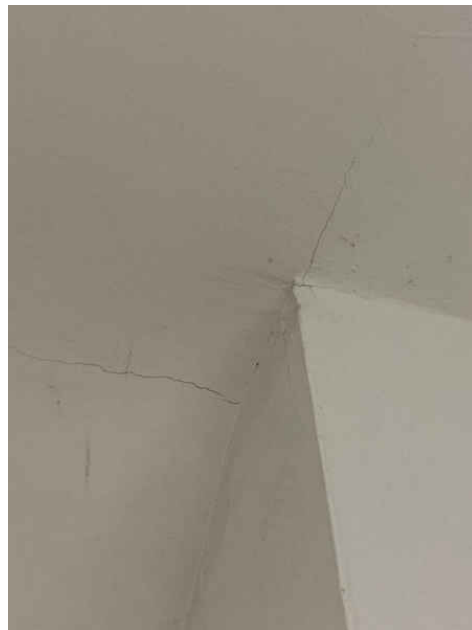
CRACKS - MINOR

Minor cracking was observed in several wall/ceiling structures. This is common in homes this age and usually occurs due to climate change throughout the year. Recommend monitoring for worsening condition.

Wall Cracks

Ceiling Cracks

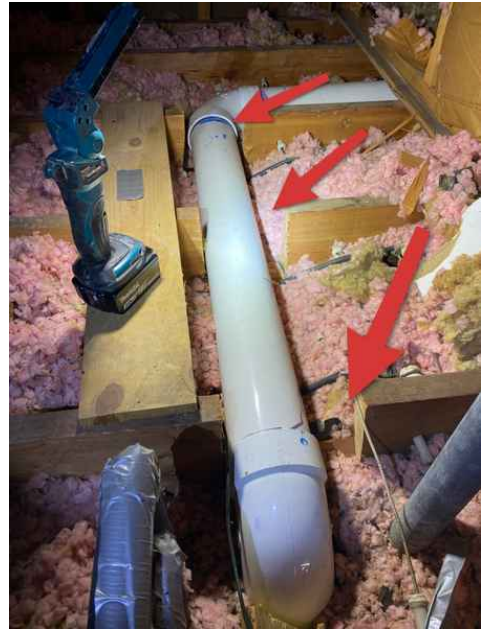
EVIDENCE OF STRUCTURAL DAMAGE

Evidence of structural damage was found in the ceiling structure. Recommend a structural engineer evaluate and advise on how to repair.

Compromised Ceiling Joists/ Attic Rear

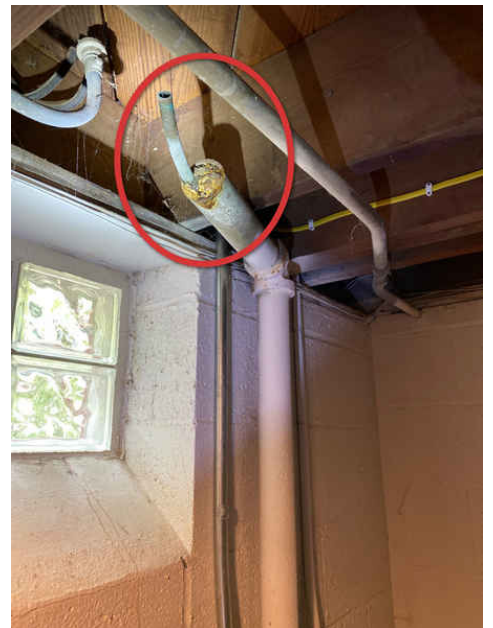
Open drain connection was observed in the basement laundry area. Improper drain connections could potentially lead to sewer gas entry into the home. Recommend consulting with a qualified plumbing professional to evaluate/repair.

Open Drain

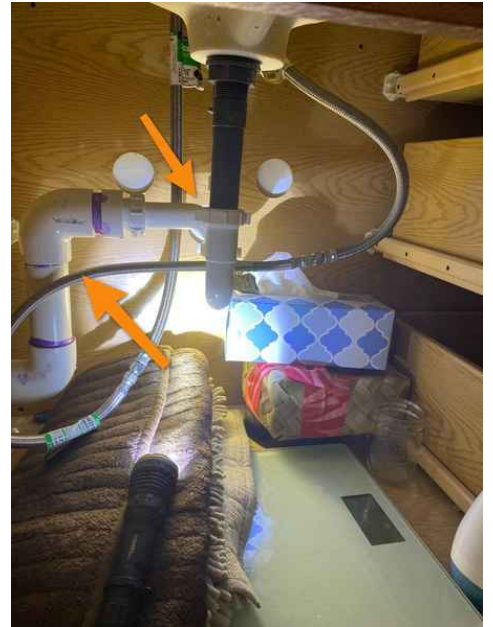
An S-Trap configuration was observed in the 2nd floor bathroom vanity. This is common in older homes but less than today's minimum building methods due to the effectiveness of the drain ventilation. This configuration is prone to siphoning of the water inside the trap which leads to potential sewer gas entry into the home.

S Trap

Recommend drain reconfiguration by a qualified plumbing professional.

Contact a qualified professional.

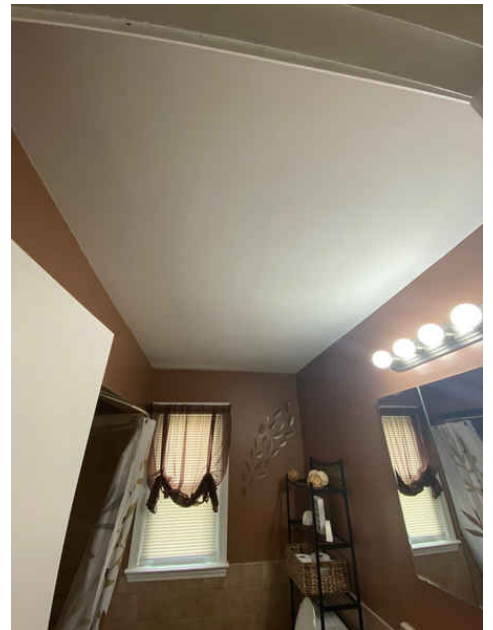
Missing Bathroom Exhausts

Contact a qualified professional.

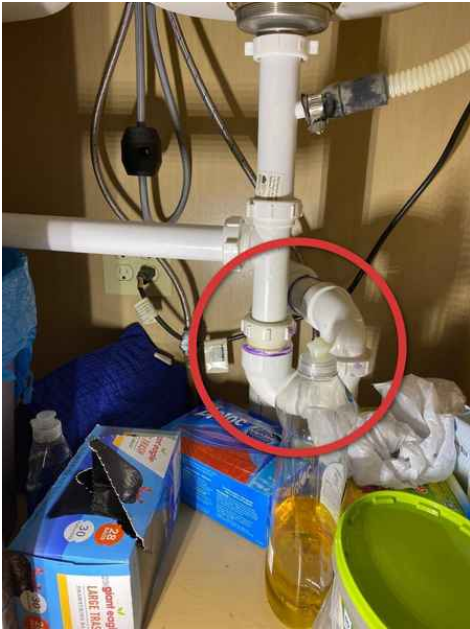
An S-Trap configuration was observed in the Kitchen. This is common in older homes but less than today's minimum building methods due to the effectiveness of the drain ventilation. This configuration is prone to siphoning of the water inside the trap which leads to potential sewer gas entry into the home.

Kitchen S Trap

Recommend drain reconfiguration by a qualified plumbing professional.

Contact a qualified professional.

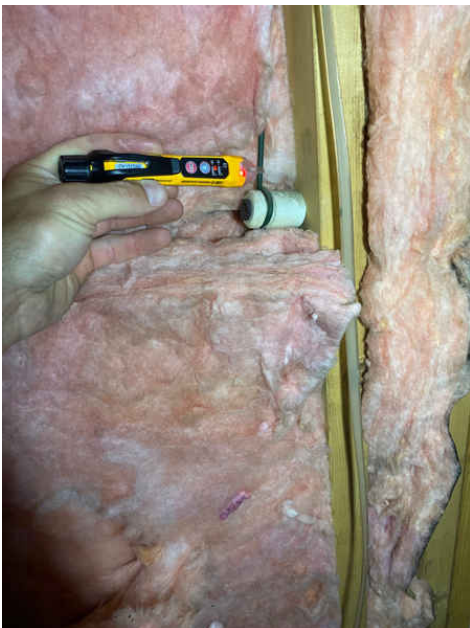
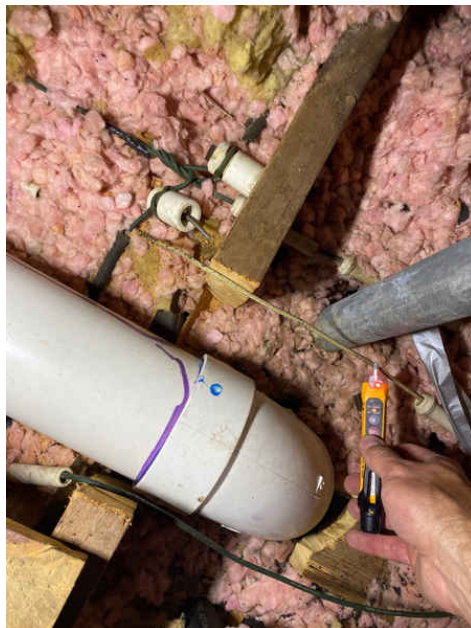
The knob-and-tube wiring in the home is obsolete and may pose an increased fire hazard. Some insurance companies are not issuing homeowners insurance for homes with this wiring. Any poor-condition or altered knob-and-tube wiring should be replaced. Extensive replacement can be a significant expense.

Active Knob and Tube wiring/insulation Active Knob and Tube wiring/insulation

Contact a qualified professional.

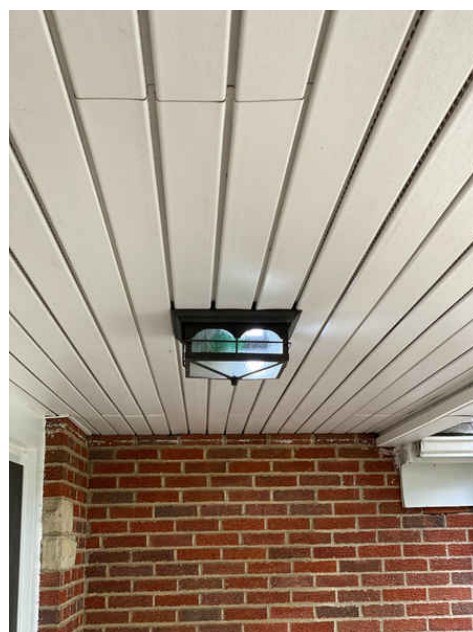
Front Porch light flashing when initially turned on

Contact a qualified professional.

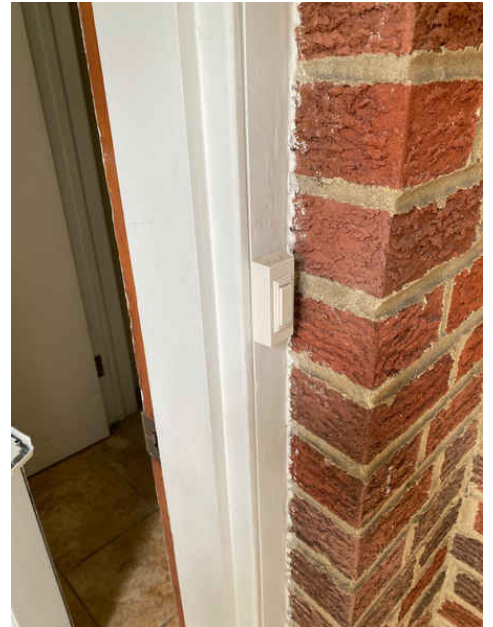
Doorbell was observed to not be functioning. Recommend consulting with a qualified professional to repair/replace.

Inoperable Doorbell.

Contact a qualified professional.

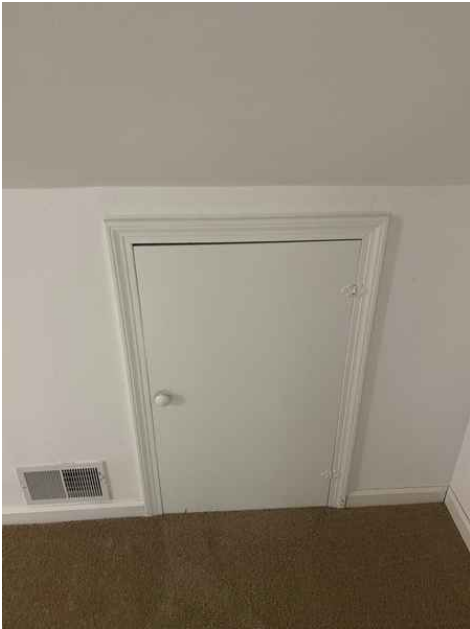
INACCESSIBLE

2nd Floor front attic access won't open

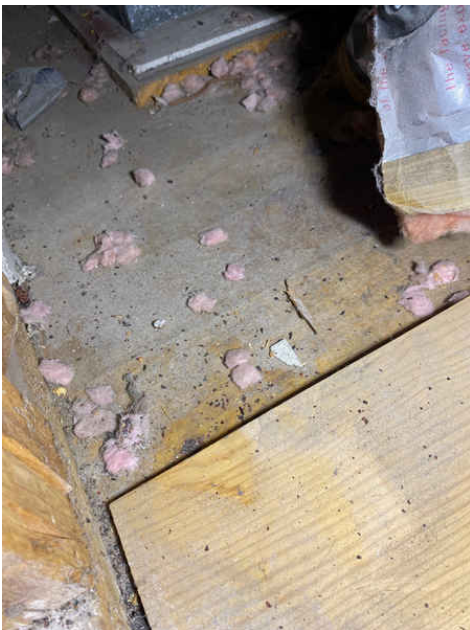
Evidence of mouse/animal activity was observed in the attic/front. It could not be determined if this is recent sign or a previously addressed issue. We recommend consulting with a pest control specialist for treatment and control advice.

Mouse Activity

Contact a qualified professional.
